Water retention measures must be accompanied by active revitalization of vegetation. A case project: Slovenská Ves

N. MAXIMOVÁ¹, R. ŠOLTÉS¹, J. SOLÁR¹,
J. SLIVINSKÝ² and M. JANIGA¹

¹*Institute of High Mountain Biology, University of Žilina, Tatranská Javorina 7, 05956-SK, Slovak Republic, e. mail: maximova@uniza.sk;* ²*Municipal Authority Slovenská Ves 50, 05902 Slovak republic*

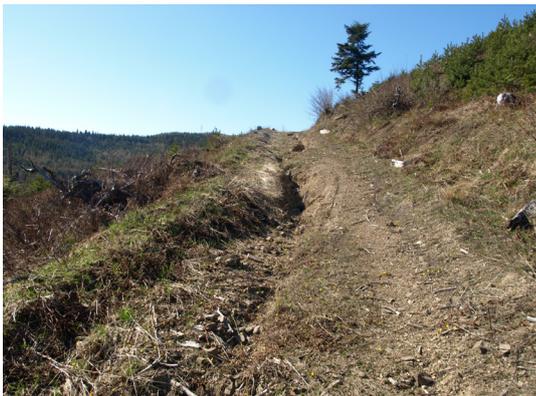
Fig. 2. Erosion groove caused by runoff (April 20, 2011, photo: J. Slivinský)

A considerable number of forest roads is badly damaged. The surface of most roads is not equipped with diverters, which leads to the formation of erosion furrows. Another issue of the same importance is the slope of forest roads. Roads transversing slopes are tilted towards the slope and prevent the water from running off into vegetation. This results in the formation of deep erosion furrows reaching dozens of centimetres (Fig. 2, see appendix).

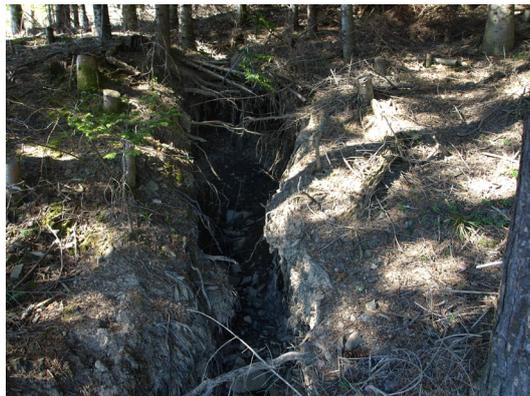
Fig. 3. Erosion ravine, depth of 1.5 m formed by accumulation of surface water runoff from several forest roads in the village of Slovenská Ves (April 20, 2011, photo: J. Slivinský)

Infiltration of rain water into the soil is closely related to the condition of the overlying topsoil layer. If this layer is disrupted by the forest management processes, runoff and erosion soil transport are immediately increased, and thus the flow instability, too (Mindáš *et al.* 2001). The water running down the surface of the forest roads creates erosion furrows in the forest landscape. In case of multiple roads crossing, synergetic effect can be observed. Water flowing from a maze of roads accumulates and creates erosion ravines with a depth of several meters (Fig. 3, see appendix). The length of logging road or forest roads, relief elements (slope, slope exposure) and the amount and intensity of precipitation are the determinants of the runoff volume and therefore of the erosion ravine formation.

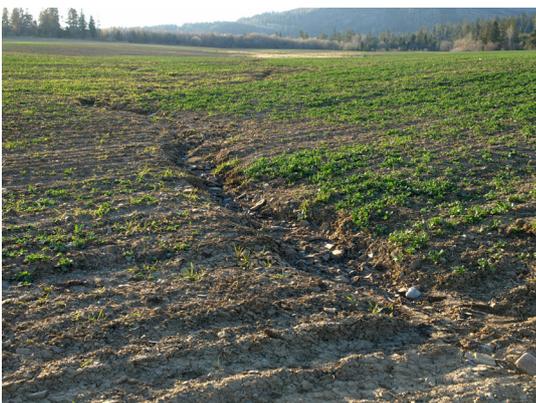
Fig. 4. Erosion groove resulting from surface runoff caused by waterlogged areas in the midfield (April 20, 2011, photo: J. Slivinský)

In the damaged arable land at the time of extreme precipitation erosion grooves are formed. Loam to clay-loam farmland soil on the inner Carpathian flysch bedrock is characterized by a lower retention capacity. Abundant rainfall leads to an over saturation of the soil surface by water. Wet areas remain in the field depressions, where rainwater is accumulated. Such basins present large drainage areas, feeding flows that run down agricultural roads (Fig. 4, see appendix).

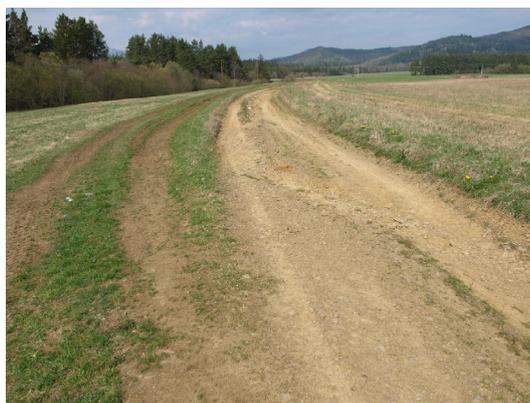
Fig. 5. New parallel field road along original field road in the village Slovenská Ves (April 20, 2011, photo: J. Slivinský)

water erosion. The use of heavy agricultural machinery especially after extreme rain leads to the formation of deep tracks, often solved by making parallel roads after the original road becomes impassable (Fig. 5, see appendix). This phenomenon seems to be the rule that can be seen almost along all agricultural roads.

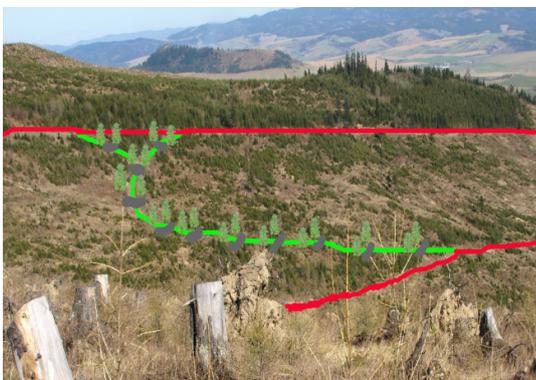
Fig. 6. Forest roads above Slovak creek (April 20, 2011, photo: J. Slivinský)
 forest road - Green - obliteration - cross pits with planting alder (*Alnus incana*)
 forest road - Red - restoration - diversifiers, local slope correction

Obliteration of temporary approach roads by digging cross pits. Selected deciduous trees with high retention capacity are planned to be planted next to the pits (Fig. 6, see appendix).

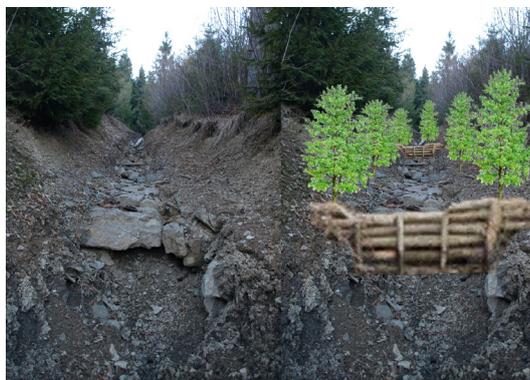
Fig. 7. The proposed model of water dikes in forest erosion groove (left - the current state; April 20, 2011, photo: J. Slivinský, right - suggestion flood measures)

One of the measures for the improvement of the damaged parts of the landscape has been the construction of wooden dikes into the erosion ravines up to 1 m high. Construction of dikes alone is not a full flood preventing measure. When the compactness of soil surface is damaged and disrupted by the removal of wood, the soil absorption capacity decreases. The surface runoff is most affected especially in flysh areas where even a small decrease in the forest cover is reflected in significant increase of maximum runoff volumes (Mindáš *et al.* 2001). Therefore the solution we proposed involved planting of trees with high retention capacity (Fig. 7, see appendix).

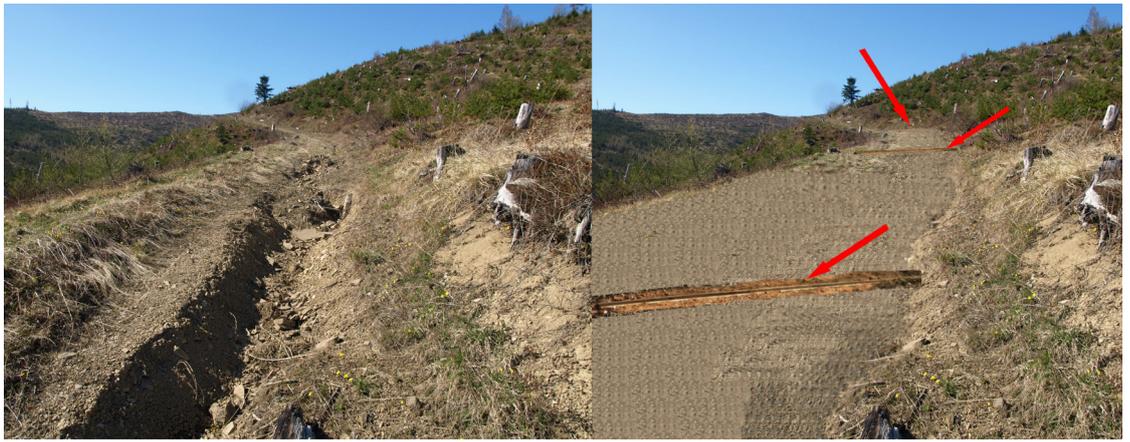
Fig. 8. Working forest road - diverters, local slope correction (left – present state; April 20, 2011, photo: J. Slivinský, right - suggestion flood measures)

Diverters are constructed on working roads. The number of diverters should depend on the slope angle and local slope angle correction of the road. Local slope correction (carried out by heavy machinery) was chosen for a better water dispersion capability in the areas under the road in terms of retention characteristics ("finer" water dispersion) than the diverters themselves. In fact diverters concentrate the water into series of minor flows, which are less efficient in using the absorption capacity of the area below the road (Fig. 8, see appendix).

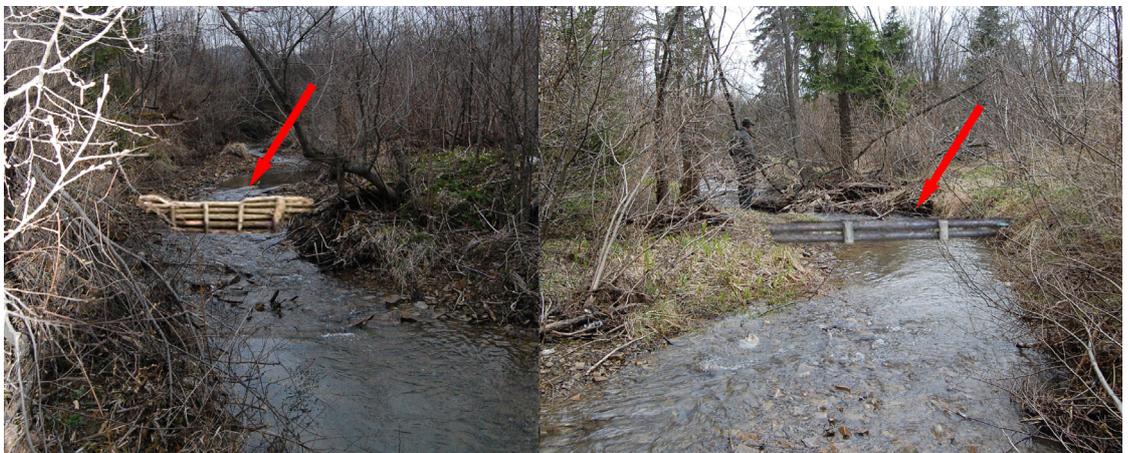
Fig. 9. Slovak creek (17 dikes) – sills, steps, dikes (April 15, 2011, photo: M. Janiga, simulation of waterholding measures)

The following three water streams were selected for the implementation of this measure: upper part of Vojňanka, upper part of the Slovak creek and periodically drying water stream in an area called Mokryny. In these locations we have designed the construction of approximately 60 cm high wooden dikes (possibly steps, sills) (Fig. 9, see appendix).

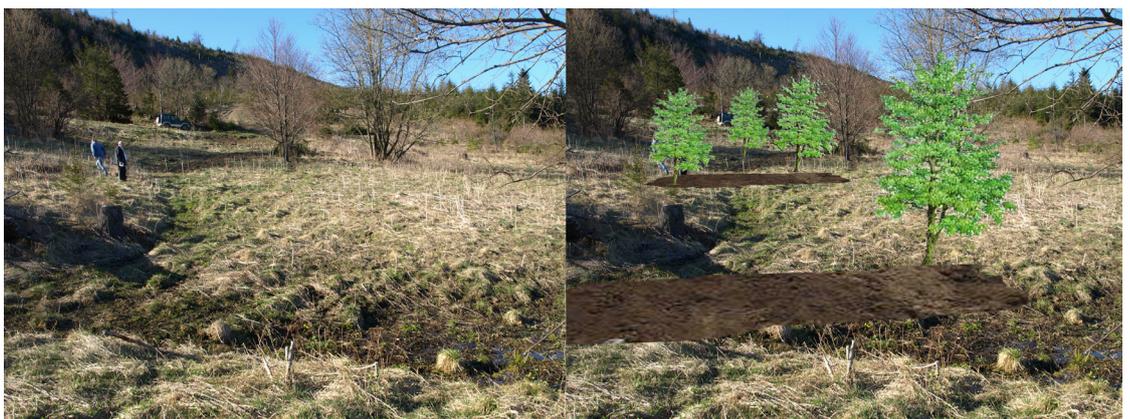
Fig. 10. The absorption ditch with retention area (left – present state April 20, 2011, photo: J. Slivinský, right - suggestion flood measures)

In this case we proposed constructing wooden dikes or absorption stripes and planting trees (Fig. 10, see appendix).

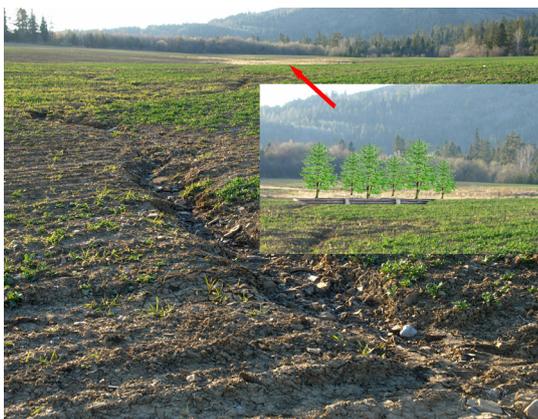
Fig. 11. The sloppy parts above the Jewish cemetery. Construction of waterholding measures on waterlogged farmland – dikes, tree planting (April 20, 2011, photo: J. Slivinský).

This proposal consists of two steps. Building the wooden dikes on sopping agricultural land and planting gray alder tree (*Alnus incana*) (Fig. 11,

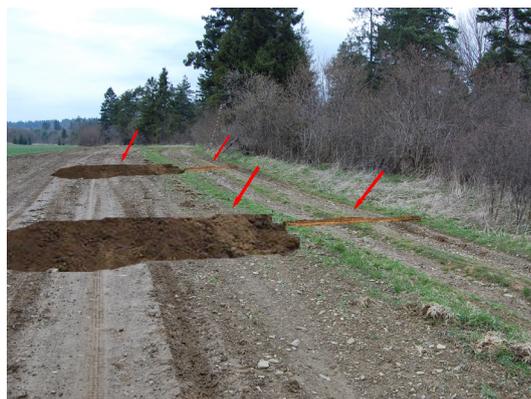
Fig. 12. Proposed measures on unused unimproved agricultural road above the Jewish cemetery – absorption ditch and hoeing of road surface (April 20, 2011, photo: M. Janiga)

Landscape and water management consist of creating a complex of waterholding absorption ditches connected to the water diverters on agricultural land road and their outlets into the meanders of the Slovak creek and finally construction of dikes in the stream. Our goal was not only to design the mechanical measures but especially to make the best use of the landscape's retention potential (Fig. 12, see appendix).

1st stage - building the absorption ditches in the optimal direction according to the presumed water direction during an extreme rainfall as well as in the areas far from the stream

2nd stage - building the diverters on the road connected to the absorption ditches and then conveying the water to the meadow section of the meander in order to capture as much rainfall as possible using the biotic potential of the landscape

3rd stage - building dikes on the Slovak creek with height of up to 60 cm, assuming that the succession of measures will lead to a more balanced flow rate in the stream, thus increasing its retention capacity
